No 49 High Street
(Currently Lawrence Estate Agents)

The reason for the group interest in this building stems from the fact that in its original construction it was a medieval hall house. On 19th May 2015 the buildings project team toured the property. All measurements are imperial due to the plans being expressed in that medium.

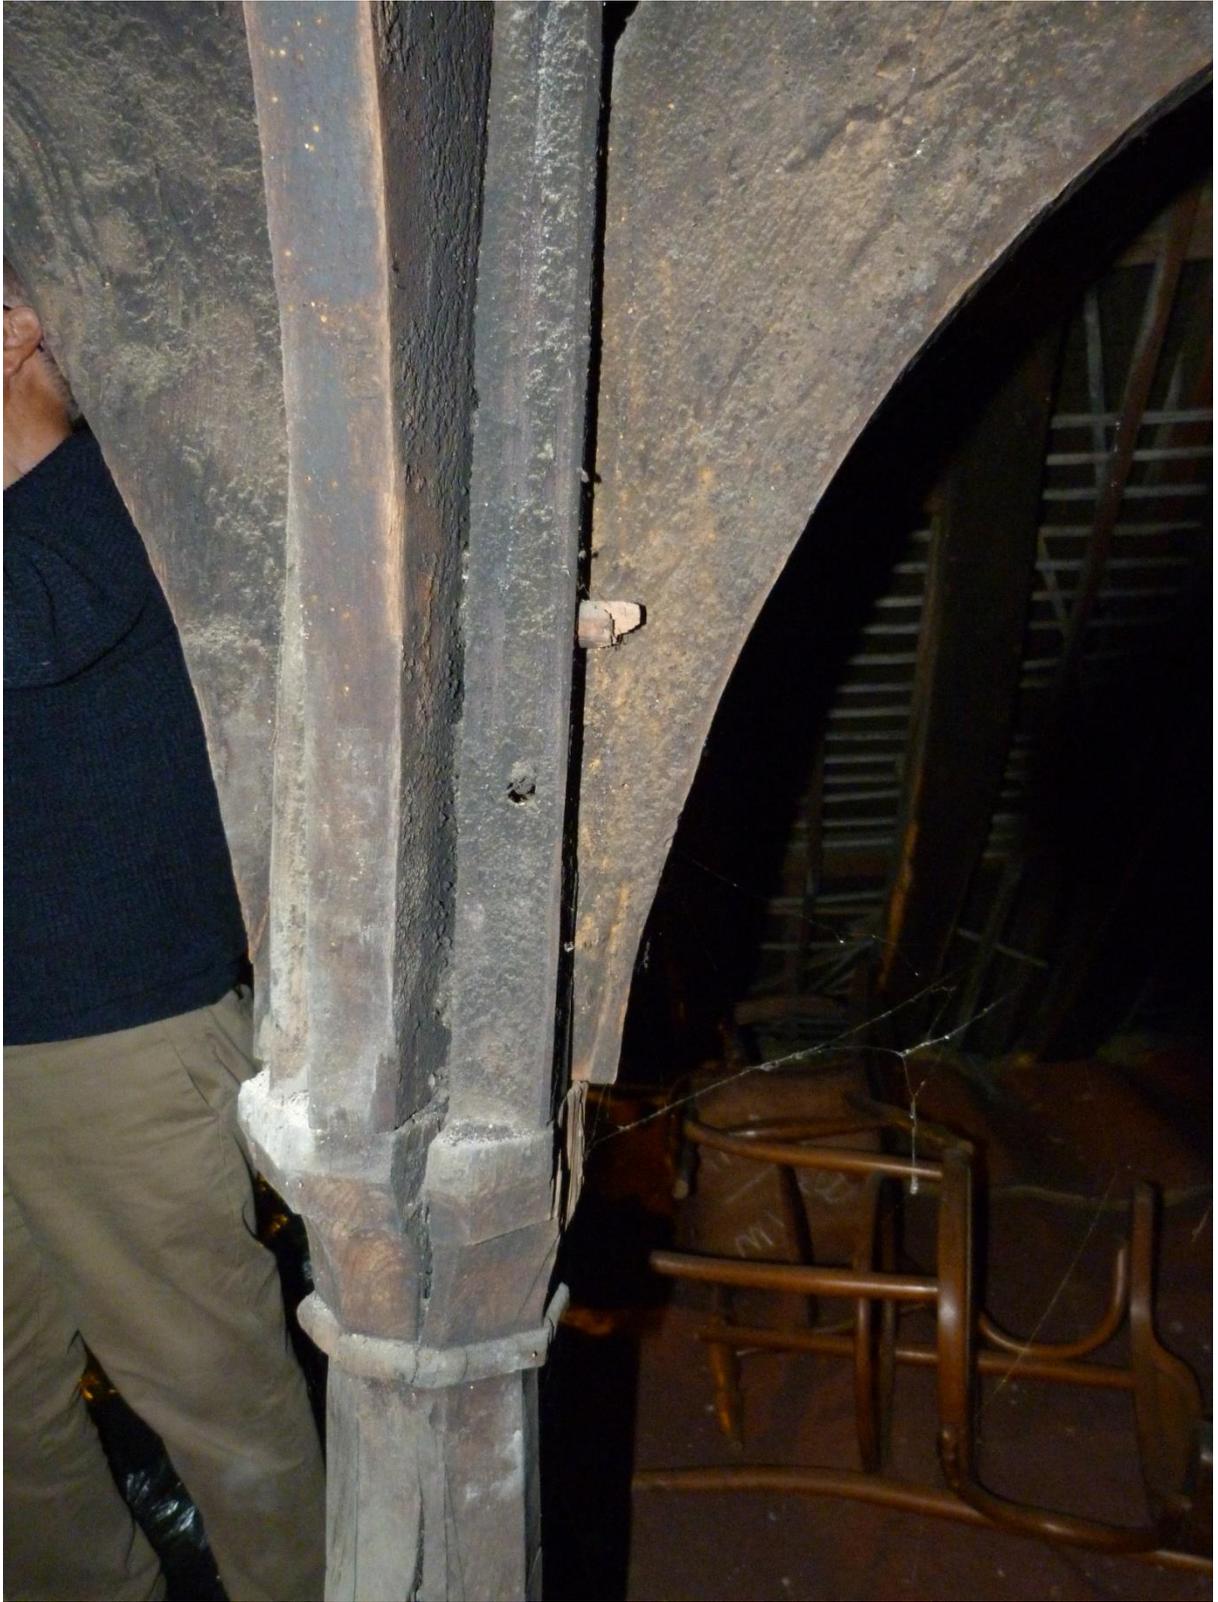
Crown Post

The open truss in the void with the short crown post would be in normal hall houses, in the centre of the hall. This is not exactly the case with this property as it stands, so the question is what was the extent of the old hall? Which way did it run? Was the mysterious beam in the centre of first floor room to the east, the extent of the hall and perhaps the remnants of a closed truss halfway up the old building? Was the separate range added at some later date? Are there any signs of a dais beam giving further clues to the layout of a hall?

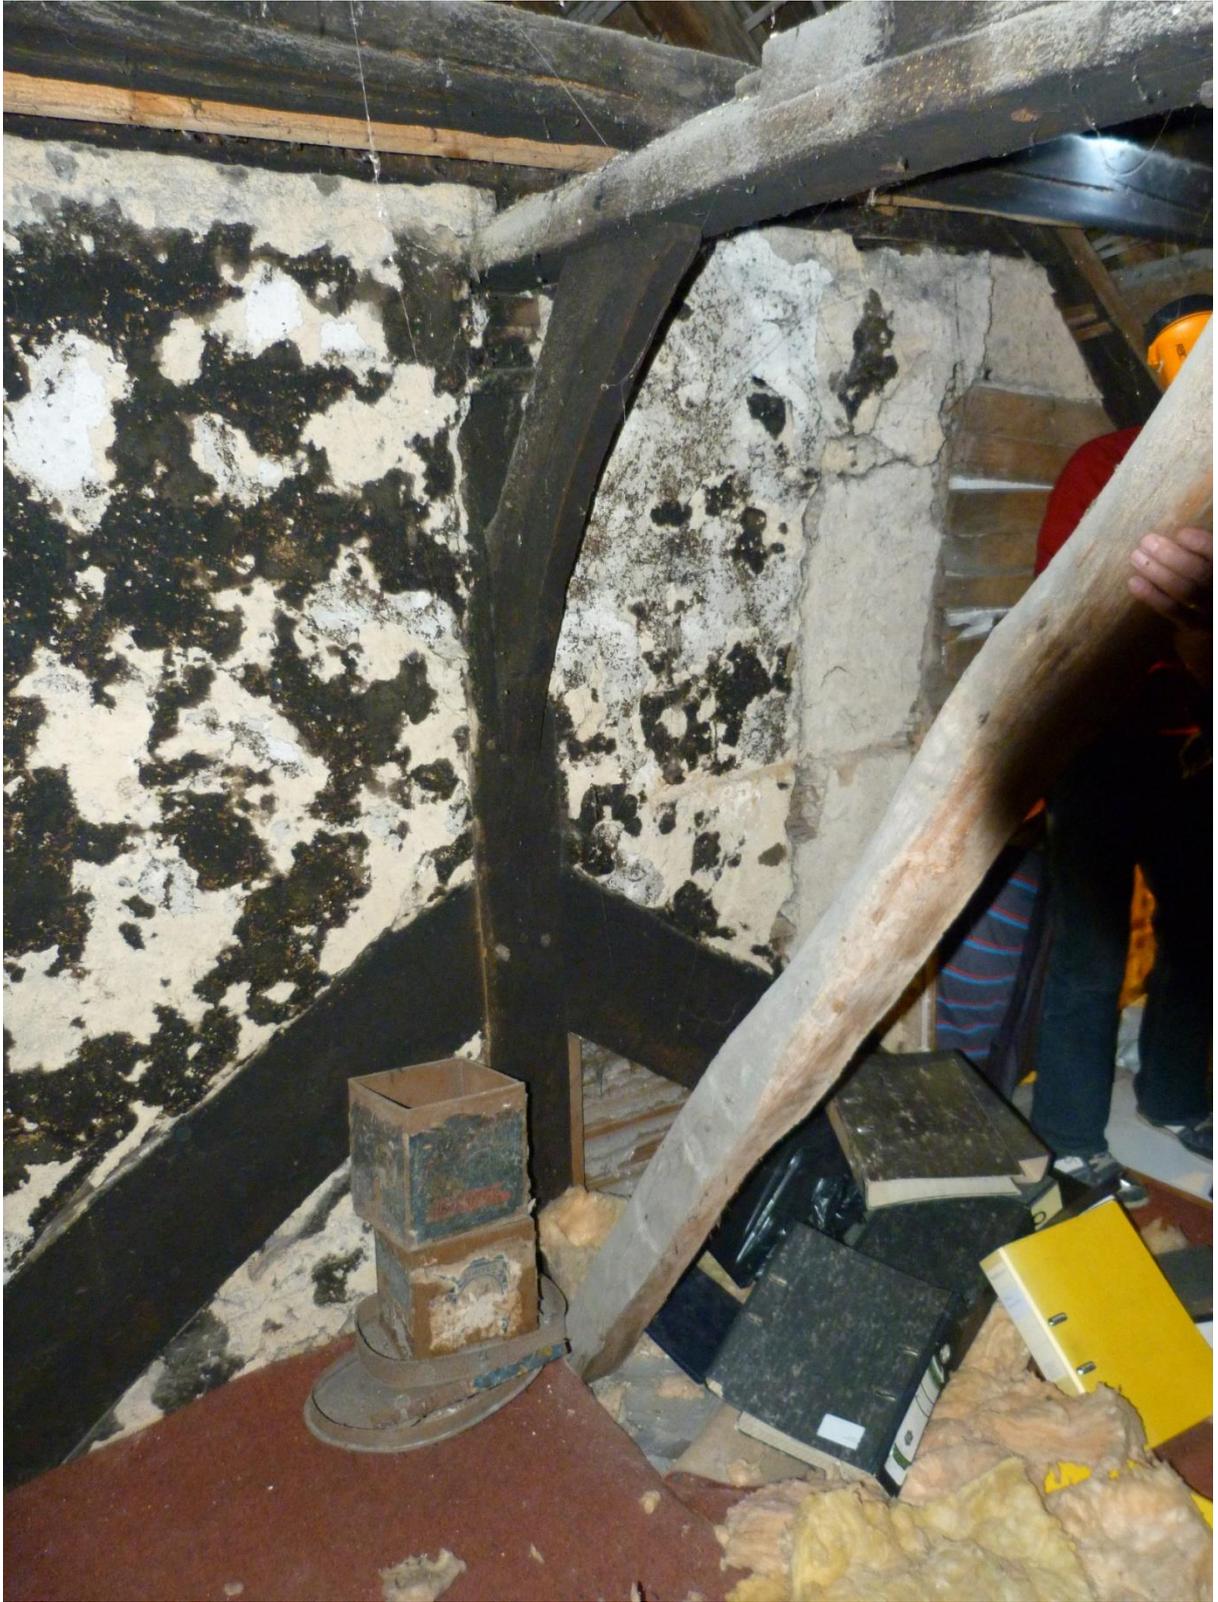
Smoke Blackened east wall in roofvoid
